Manhole Inspection Summary

Manhole # S61I__007MH

Insp Date: **3/24/08 1:19 PM**

Location Address: **501 Rappolla St.**

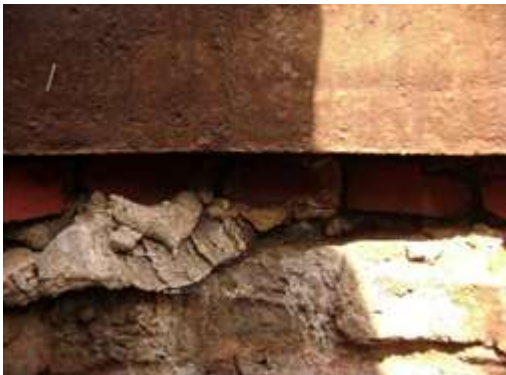
Defect 1

Condition: ☐ Sound ☐ Cracked ☐ Root Intrusion ☒ Loose Brick ☒ Deteriorated

DETERIORATION AT FRAME SEAL

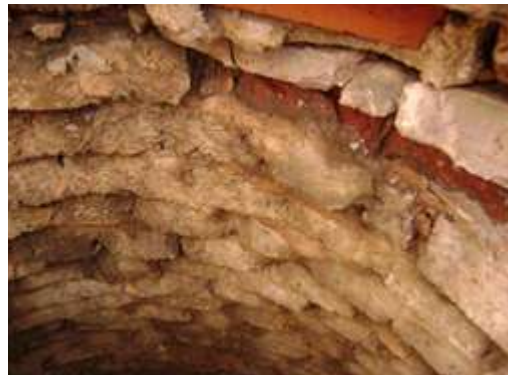
Defect 2

Infiltration: ☐ None ☒ Joint ☐ Cracks ☒ Mortar ☐ Roots ☐ Wall

LOOSE BRICKS AND INFILTRATION

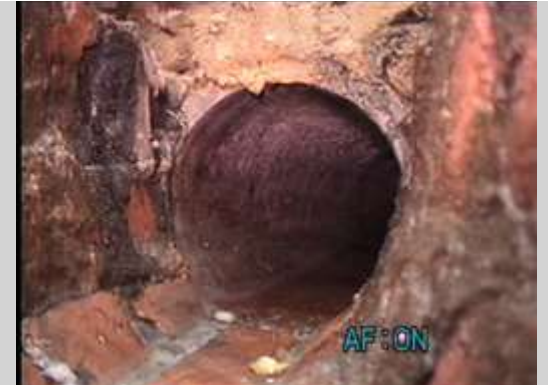
12 O'Clock Outflow

8 in. Circular Gravity Sewer
Pipe Out @ 12 O'Clock

Pipe Height: **8.4** (in.) Rod and Bar (Angled)
Pipe Material: **Clay** ☐ Pipe Lined
Invert Depth: **5.59** (ft.) Flow Characteristics: **Slow**
Deposits: ☒ None ☐ Mud ☐ Sludge ☐ Debris ☐ Grease
Silt Depth: (in.) Deposits Extent:
Infiltration: **None** Pipe Seal Cond: **Sound**

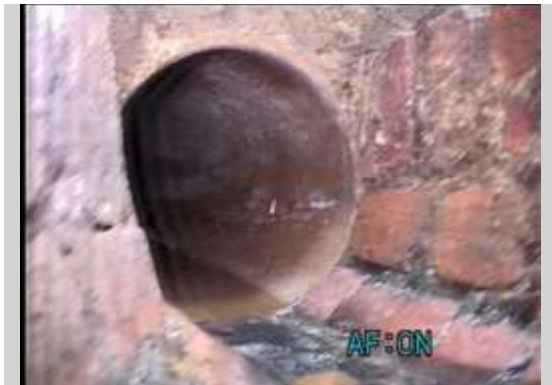
3 O'Clock Inflow

8 in. Circular Gravity Sewer
Pipe In @ 3 O'Clock

Pipe Height: **8.4** (in.) Rod and Bar (Angled)
Pipe Material: **Clay** ☐ Pipe Lined
Invert Depth: **5.54** (ft.) Flow Characteristics: **Slow**
Deposits: ☒ None ☐ Mud ☐ Sludge ☐ Debris ☐ Grease
Silt Depth: (in.) Deposits Extent:
Infiltration: **None** Pipe Seal Cond: **Sound**
